Manhole Inspection Summary

Manhole # S15E1_012MH

Insp Date: **5/23/08 1:36 PM**

Location Address: **3101 gable-patapasco**

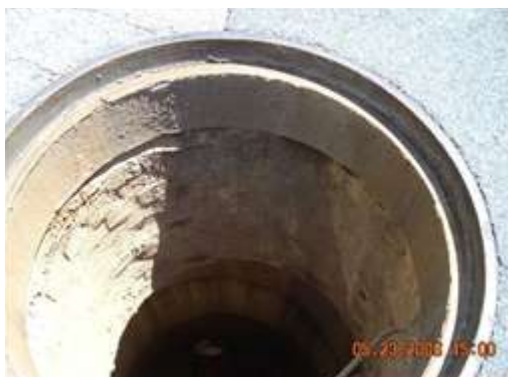
Misc. Inflow Evidence

Subject To Ponding: **Sheeting**

inflow evidence from sheeting

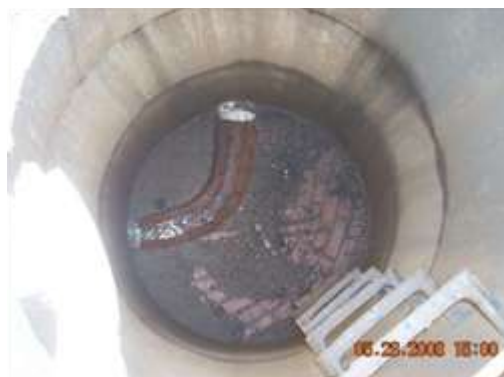
misc

bench debris

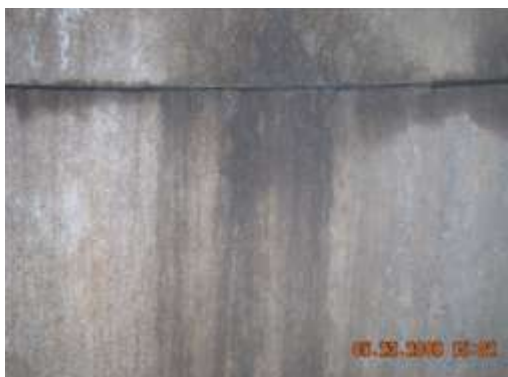
Defect 1

Infiltration: ☐ None ☒ **Joint** ☐ Cracks ☐ Mortar ☐ Roots ☐ Wall

infiltration @ corbel/barrel joint

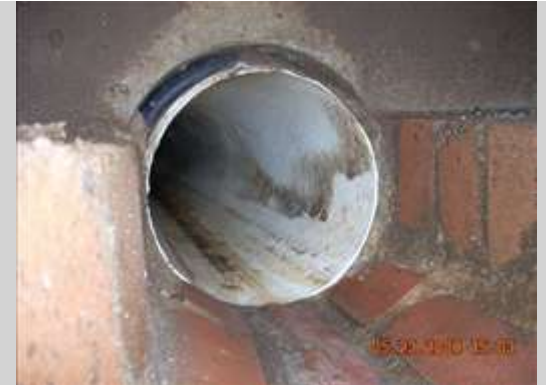
12 O'Clock Outflow

8 in. Circular Gravity Sewer
Pipe Out @ 12 O'Clock

Infiltration: **None** Pipe Seal Cond: **Sound**

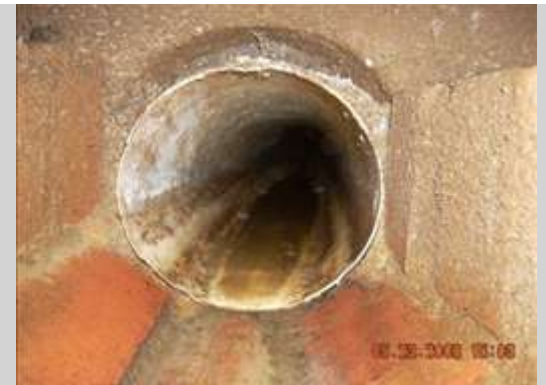
9 O'Clock Inflow

6 in. Circular Gravity Sewer
Pipe In @ 9 O'Clock

Infiltration: **None** Pipe Seal Cond: **Sound**
